**AEC Investigation of Cobalt-60 Exposure  
at the  
Variable Dose Rate Irradiation Facility, UT-AEC**

(Report of Investigating Committee)

**February 4, 1971**

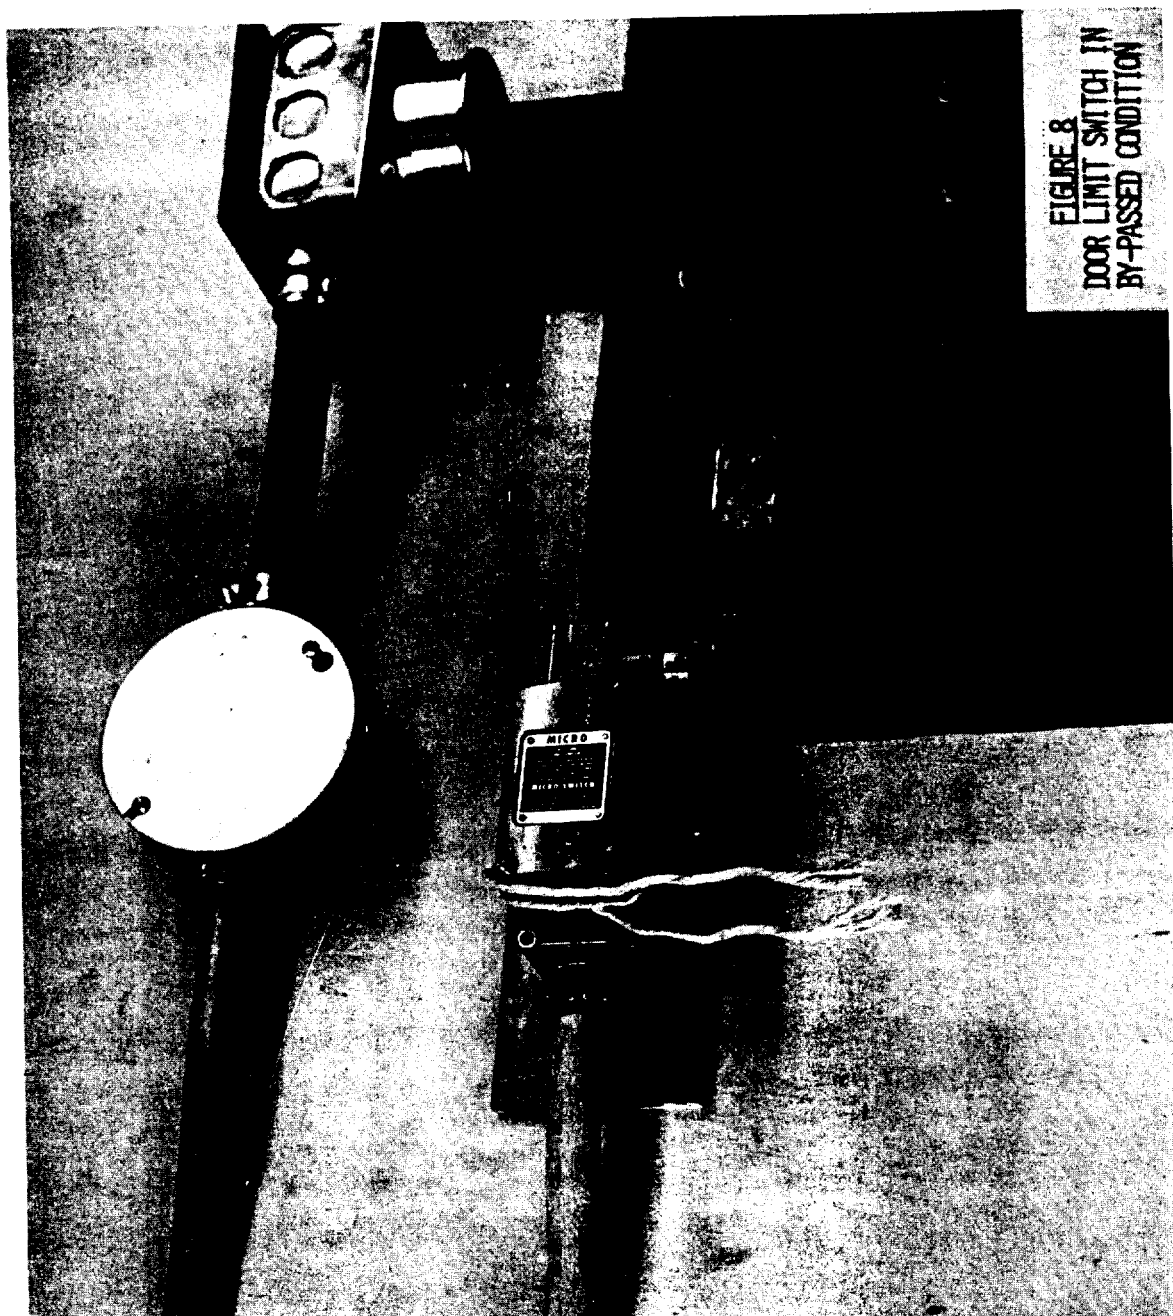
FIGURE 8  
DOOR LIMIT SWITCH IN  
BY-PASSED CONDITION

- A. Based on the findings of fact, the committee concludes that the condition of the facility on February 4, 1971, was such that only the proper functioning of the door limit switch would have automatically prevented entry into the source room with sources exposed. Therefore, in view of its proper functioning during tests before and after the incident, it appears most credible to the committee that the door limit switch had been inadvertently left tied in the closed position following operations on February 2 or 3, 1971.

2. The door limit switch actuator should be modified so that the switch cannot slip past the actuator and falsely indicate that the door is open.
  3. The position indicator system should be replaced or supplemented by a simpler more direct measuring system that does not depend upon the encoder which controls positioning, preferably driven by the drive train downstream of the decoupling mechanism.

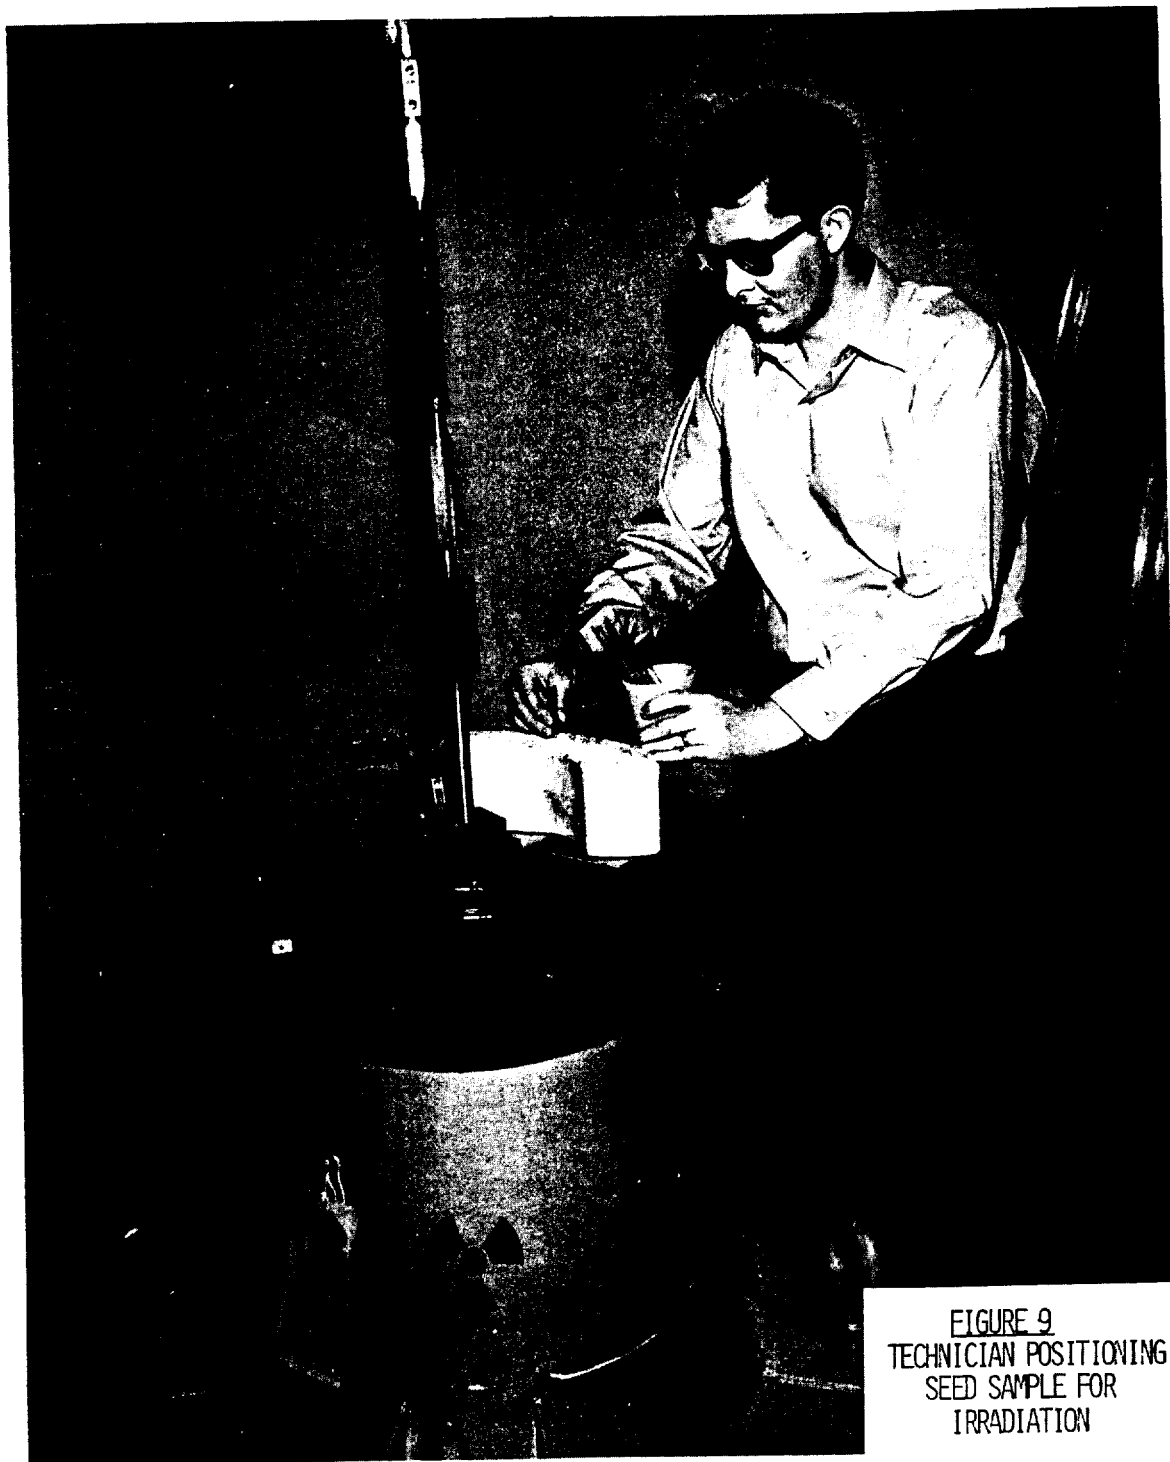
FIGURE 9  
TECHNICIAN POSITIONING  
SEED SAMPLE FOR  
IRRADIATION

disengaged all sources except No. 5 from the drive mechanism which raises the sources since only Source No. 5 was to be used. Employee A meanwhile loaded the four vials for Treatment No. 2. The position of the samples for the experiment is shown in Figure 9.

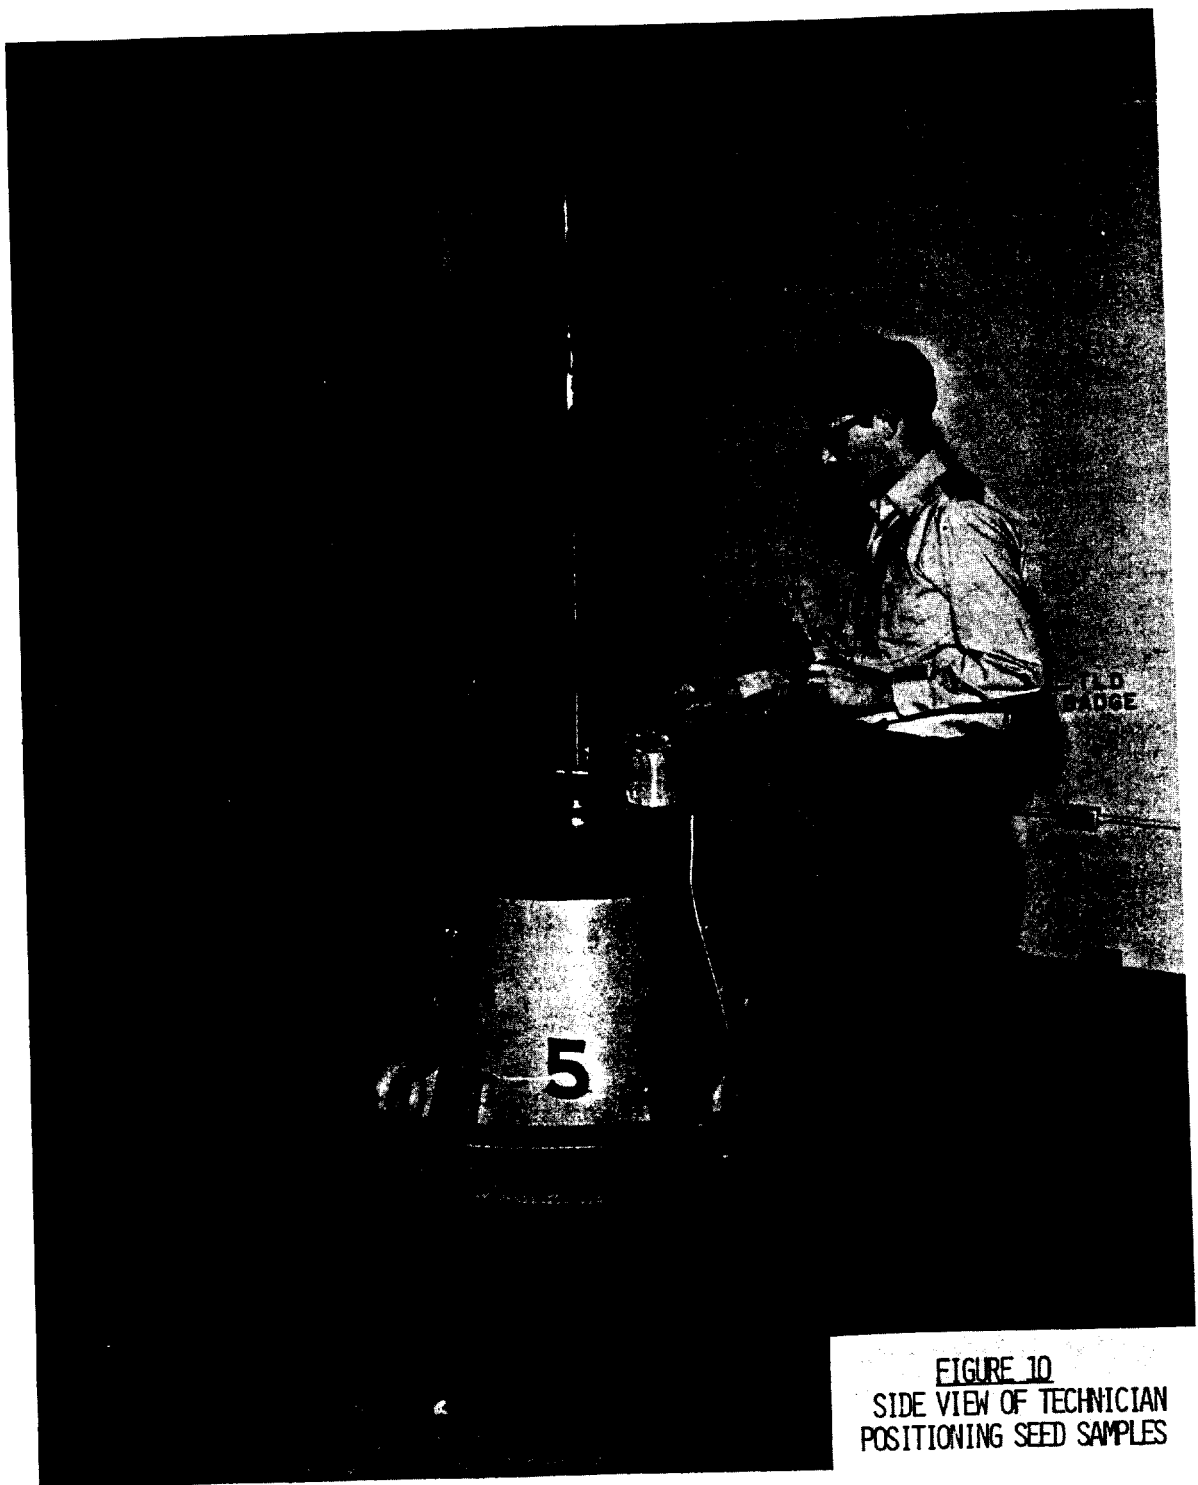
An attempt was made to provide confirming back up to the badge dosimetry by reconstructing the position of Employee A and the duration of his exposure. Figure 10 is a representation of Employee A's position while unloading and reloading the samples at the time of his exposure. It is noted that the circular wire fence around the source shield is not anchored to the floor; however, based on Employee A's recollection of the operation, it is felt that he would have been no closer to the source than would be required to comfortably reach the sample holder. This position places the badge at 50 cm from the center line of the source rod. In this position, the head is 40 cm from the source rod. Using Lithium Fluoride thermoluminescence and low-Z silver metaphosphate glass dosimeters, the dose rate at the badge was determined to be 570 R/min. It is estimated based on the timed reenactment of the operation that Employee A could have been in approximately this position for 25 to 35 sec. This would place the total body dose estimate at 240 to 340 Rem for this closest proximity to the source. A quality factor of "1" was used in all conversions of roentgens to rems.

If it is assumed that the wire fence was positioned concentrically around the source (as the anchor bolt holes in the floor suggest it had been at some previous time), the distance from source to badge could have been as great as 69 cm and the dose rate would be 390 R/min. Based on the above exposure times, the probable minimum total body dose estimate would be in the range of 160 to 240 Rem.

FIGURE 10  
SIDE VIEW OF TECHNICIAN  
POSITIONING SEED SAMPLES
