## INJURY DUE TO ACCIDENTAL HIGH-DOSE EXPOSURE TO 10 MeV ELECTRONS\*

**Abstract**—An industrial worker was accidentally exposed to a 10-MeV electron beam from a linear accelerator. Dosimetric information was assembled immediately after the event, and later, through a reconstruction of the accident.

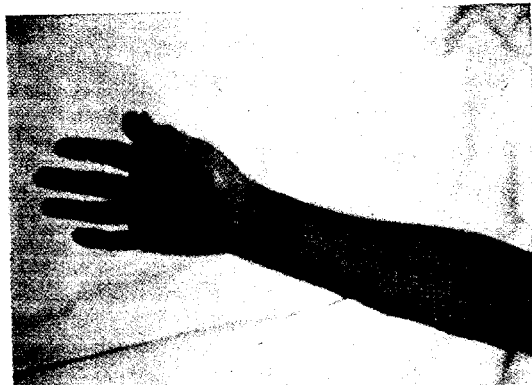
FIG. 13. Right hand, 19 February 1965, 11.00 a.m., Day 2.

Figures 13 and 14\* show the hand at 11.00 a.m. on 19 February (Day 2). There is erythema over the entire hand and the distal third of the forearm. Swelling was most marked about the thumb, beginning at its base and extending backward to the mid-forearm. Later that day, the patient described a burning sensation at the wrist between the thumb and index finger. On the following day, he complained that this thumb felt cold. On Day 4, 21 February, two bullous lesions,  $3 \times 4$  cm and  $2 \times 2$  cm, appeared on the dorsal surface of the right thumb, extending to the index finger. Medication was necessary to control pain. Although movement of the fingers was limited by swelling, there appeared to be no neurological deficit on Day 5.

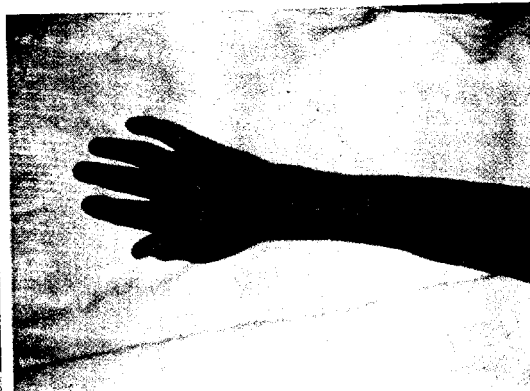
14

FIG. 14. Right hand, 19 February 1965, 11.00 a.m., Day 2. There is erythema over the entire hand. Swelling is most marked about the thumb, beginning at the base and extending to the mid-forearm.

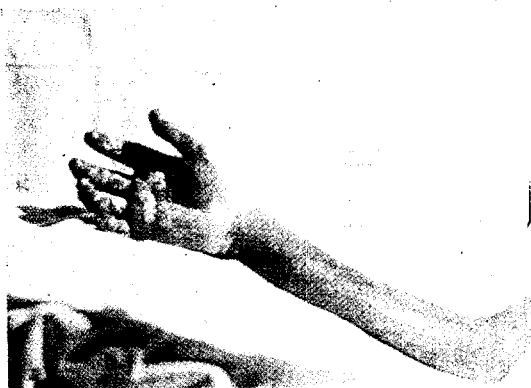
FIG. 15. Right hand, 24 February 1965, 11.00 a.m., Day 7. The white material in this and subsequent photographs is from an ointment that was incompletely removed during cleansing before photography. Bullae which formed over the thenar and hypothenar eminences are clearly visible.

Figures 15 and 16 are photographs taken on Day 7. By Day 8 the swelling had extended to the axilla and involved the anterior axillary folds and anterior chest wall. All sensation in the thumb had vanished, except for pain on movement at the metacarpal phalangeal joint. Bullae formed over the thenar and hypothenar eminences and extended into the palm. The skin over the thenar eminence turned white and the tissue below had a bluish hue. The right leg continued to show only mild erythema laterally.

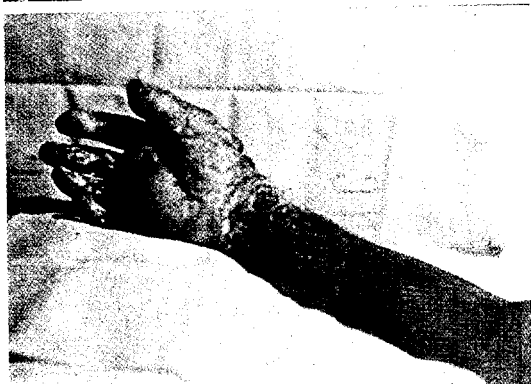
FIG. 17. Right hand, 28 February 1965, 10.00 a.m., Day 11.

On Day 9 the bullous lesions over the base of the thumb and palm continued to enlarge and weep serous gelatinous material. The enlargement, but not the weeping, ceased by

Day 11 (see Figs. 17 and 18). Edema appeared to be on the decrease, but still extended to the axilla.

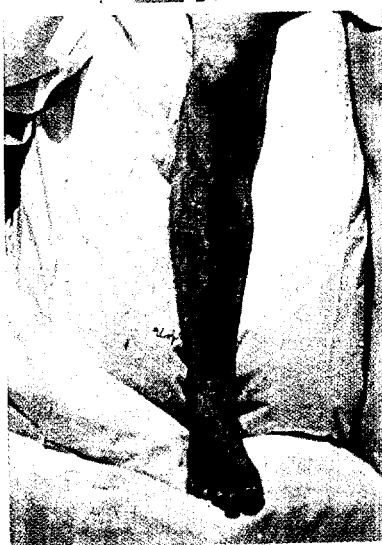
21

FIG. 21. Right foot, 28 April 1965, Day 70. Generalized erythema of the foot appeared on Day 30. Onset of tissue injury in the foot occurred later than that of hand because of the lower dose to the foot.

The delayed tissue response and the necrosis occurring after radiation injury are well illustrated by the course of events in the right foot and leg. Erythema of the anterolateral surface of the leg was present on the day of exposure, but remained stationary for twenty days before the skin broke down. Similarly, the foot appeared completely normal until Day 25, when small vesicles appeared about the nail beds. Generalized erythema of the foot appeared on Day 30, with breakdown of the skin on Day 35 (see Fig. 21, Day 70). Neuromuscular function was intact. Severe pain was treated effectively with another percutaneous cervical chordotomy aimed at the pain fibers from the lower extremity. After 3 months of observation and surface cleansing, surgical debridement was begun. Repeated discouragement was experienced as tissues that appeared to be viable one week became necrotic the next. Slow, but progressive loss of structure and loss of function of the deeper tissues followed, necessitating amputation just above the knee on 24 August, 6 months after exposure.
